Canon SERVICE MANUAL REPORT

Serial No. AC10-016

Issued by Service Department, Canon Camera Co., Inc.

REGARDING CHANGED IN CHECKING METHODS FOR SHUTTER RELEASES OF CANON FX AND PELLIX

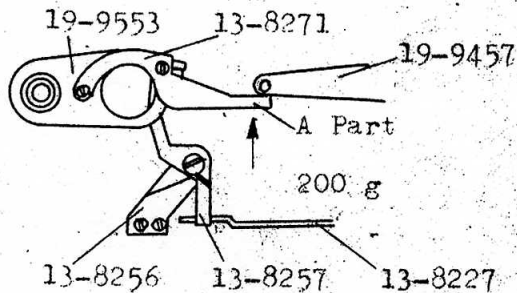
(New Checking Method)

Recently there have been many claims that the shutter does not release even though the shutter button is pressed. The reason for this is that the mirror clamp lever (13-8257) does not get released. Heretofore, the release of the mirror clamp lever was judged good when the difference between how strong the mirror charge lever (19-9553) was set and the weight of the release of the mirror clamp lever was 40 g. However, due to fluctuations in measuring and instability in the checking method, we have changed the checking method as follows:

The mirror clamp lever (13-8257) should come loose when the shutter button is pressed while pressing the A part of mirror charge lever (13-8271) at 200 g with a tension gauge.

Hereafter, the new checking method is to be applied to the service parts also.

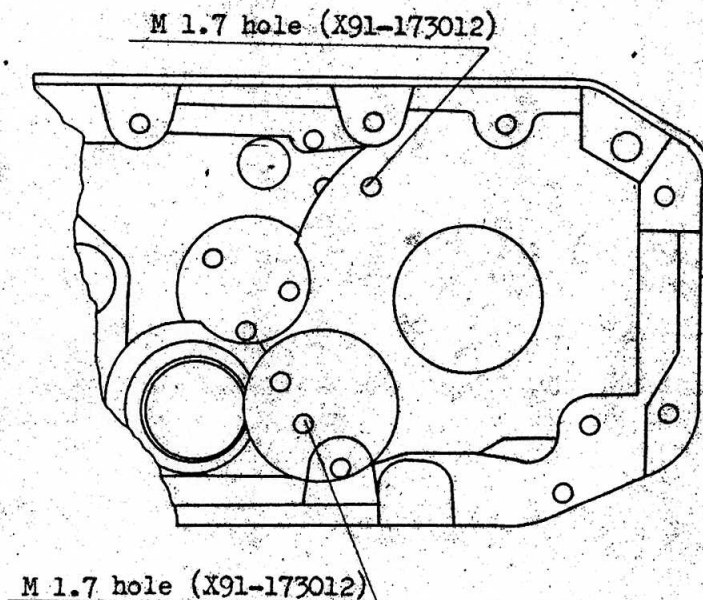
Body (19-9727) of Canon Pellix is diverted to body of Canon FX, FP at present time, however, as the body of Pellix has two more holes compared with the body of FX, FP, refer to the following diagram, if it is assembled without being covered a lid on the holes, there is a danger light might leak.

So if FX, FP which is assembled with this specific body returns to you for repair, no matter what light leaks or not, fill up screw X91-173012 to the holes mentioned above.

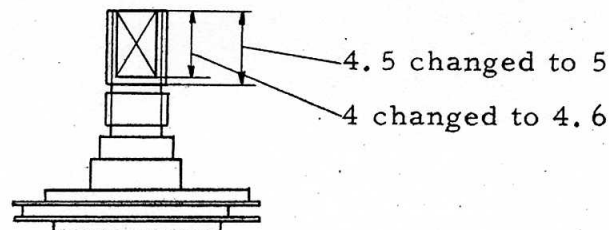
2 Shutter Speed Cam 19-9580

Oval hole position for Shutter Speed Dial 13-8155 of FX, FTQL is made altered to the same position Pellix as follows.

As for FX, if a new Shutter Speed Dial is fixed to the former Shutter Speed Cam, small end play may come out. In this case, cut down about 0.3mm at the bottom of Shutter Speed Dial, then fix it.

There is no question in FTQL, but as to FX, in case of fixing the former Shutter Speed Dial to a new Shutter Speed Cam, both Shutter Speed Dial and Shutter Speed Selector Base are not classified, therefore, take heed when the Shutter Speed Dial is replaced.

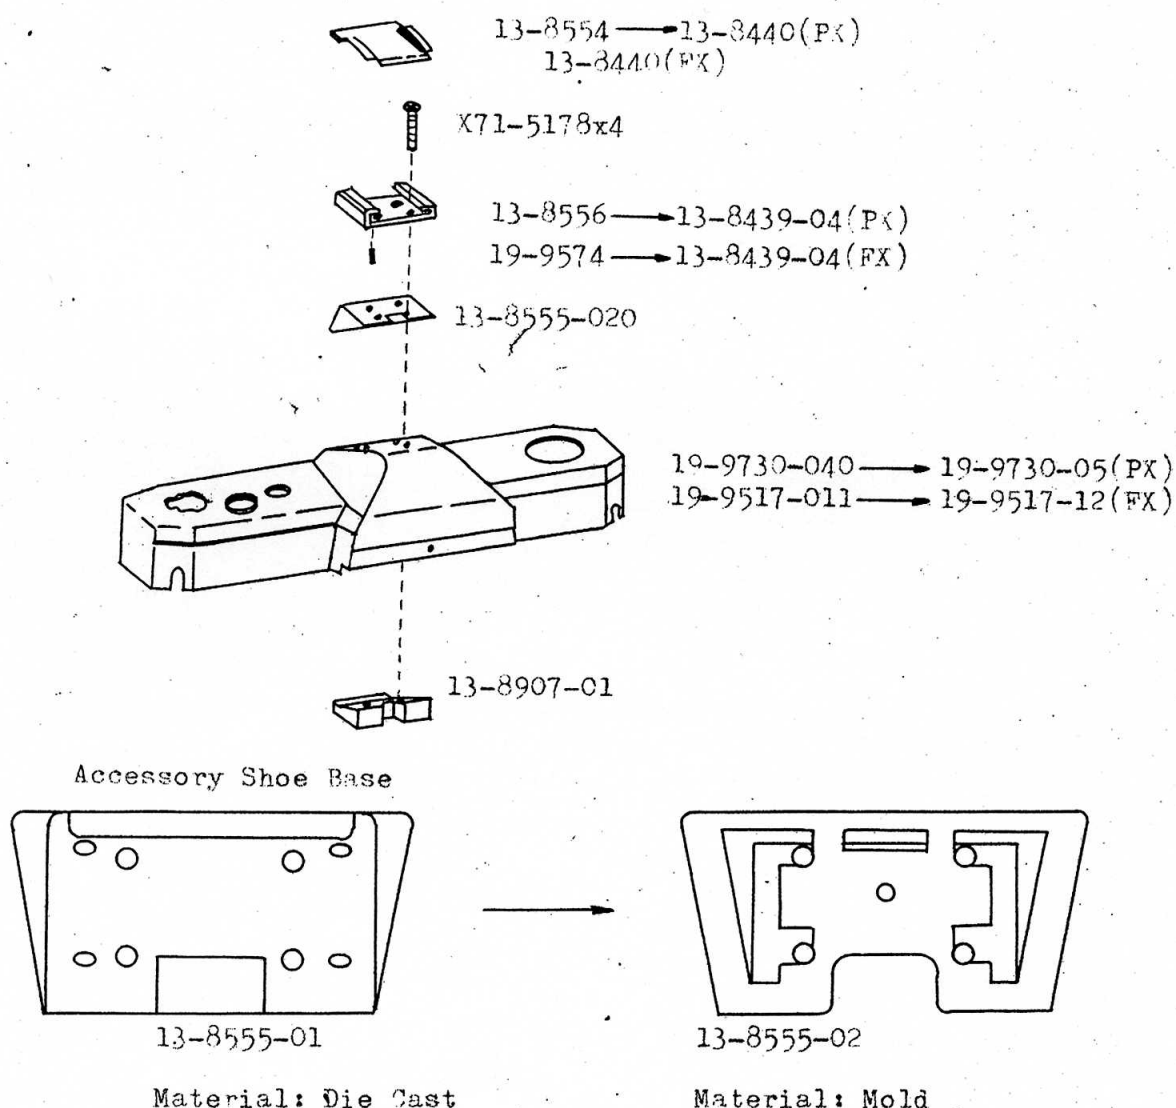
The material for the accessory shoe base (13-8555) has been changed to mold for the purpose of reducing man-hours and production costs.

Furthermore, the screw has been changed to a plus screw (X71-5178) and the accessory shoe tightening plate (13-8907) has been added.

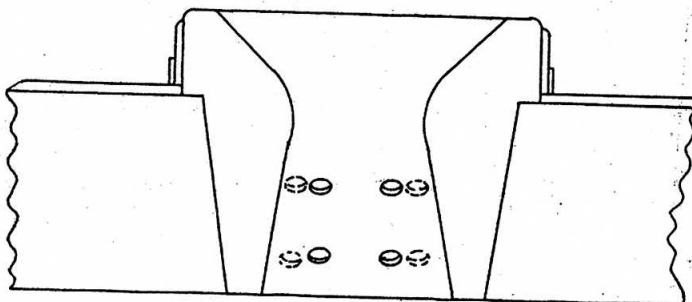
Top Cover

Position of screw hole has been changed.
Dotted line indicates old hole position.

19-9730-040 —→ 19-9730-05 (Pellix)
19-9517-11 —→ 19-9517-12 (FX)

Parts are not interchangeable.

Both the new and old parts are stored by the Service Department. Therefore, when requesting parts, be sure to indicate the parts number.

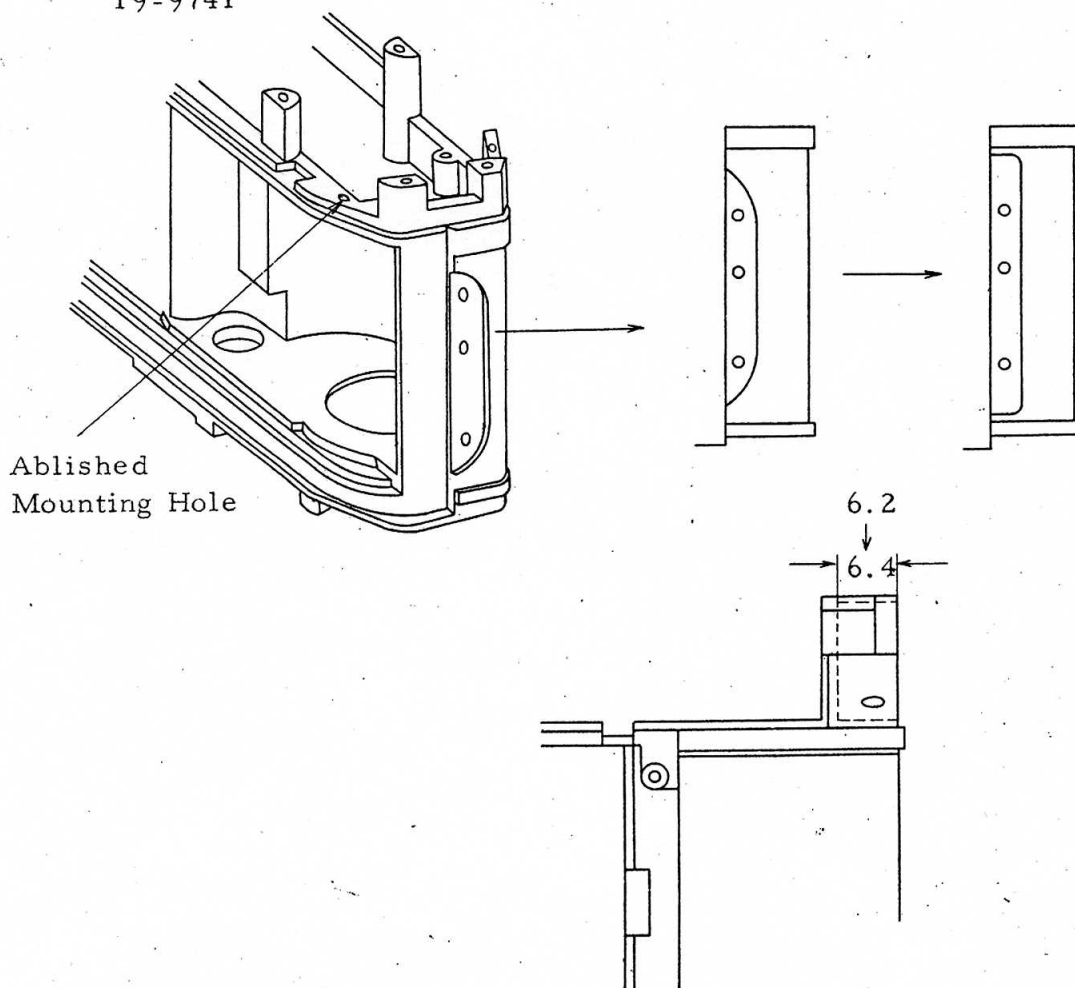
The part of Body Case (B.P.) 19-9741 where hinge is fixed, the part number has been previously altered from 19-9516, is made all common to FTQL and PXQL. The mounting hole of Screw X91-142379 for Reset Lever is abolished. The depth 6.2mm of the Mercury Battery Box is also altered to 6.4mm as well as FTQL and PXQL.

The number 13-8372 Battery Cover is altered to 13-8372-05.
The material vinyl chloride is altered to polypropylene and the
thick 0.2mm is altered to 0.4mm. The number 13-8368
Insulator is altered to 13-8368-03.

The number 13-8326 Hinge is altered to 13-8948.

Old Hinge 13-8326 can't be used to the new Body Case.
Old Mercury Cover 13-8372 can't be used to the new Body Case.
Old Insulator 13-8368 can't be used to the new Body Case
19-9741-12, but the new Insulator 13-8368-03 can be used to the
old Body Case 19-9741.

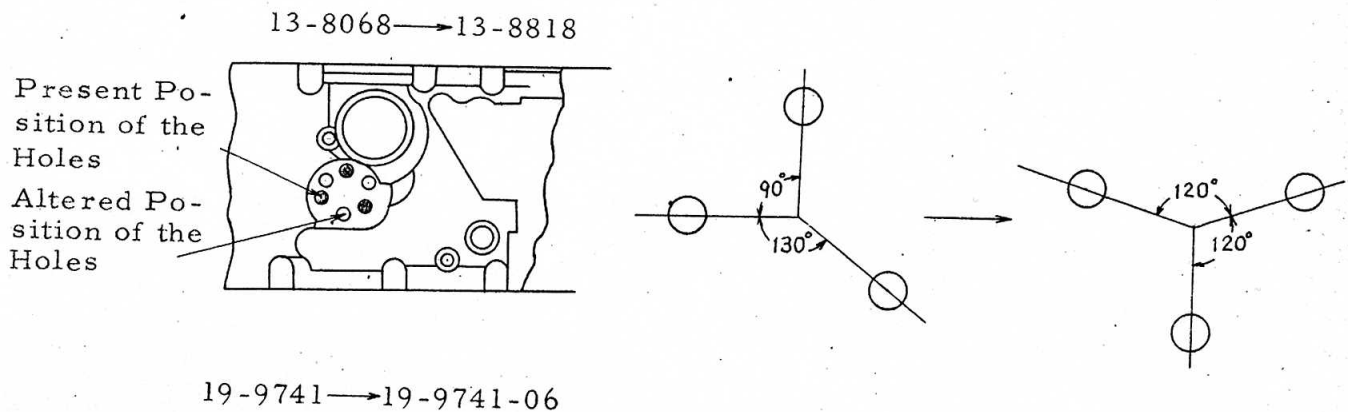
In order to rationalize the processing of perforation in the Body Die Casting 19-9741, which is made common to the processing for FT and PXQL, the position of the mounting holes for Brake Shaft 13-8068 is altered as illustrated below. Consequently, the Brake Shaft is altered to the same one which is used for FT and PXQL.

It is not possible to pair neither the present Brake Shaft 13-8068 to the altered Body Die Casting nor the altered Brake Shaft 13-8818 to the present Body Die Casting. Both present and altered Brake Shafts are stocked for spare.

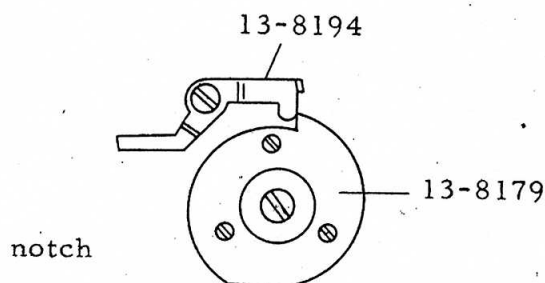
When winded up, Rewind Clamp Lever gets into notch of Cover Plate 13-8179 so that further winding sometimes becomes incompetent.

And also on the way of winding, the Rewind Clamp Lever gets in under disk and jams with gear so that return of Winding Lever (B.P.) becomes inferior. For the prevention, Rewind Clamp Lever, and Cover Plate are altered as illustrated below.

The respective present and altered parts of 13-8179 and 13-8194 are not interchangeable. If 13-8194 is replaced to the altered one, replace 13-8179 to the altered one without fail. Specify PRESENT or ALTERED parts when ordering.

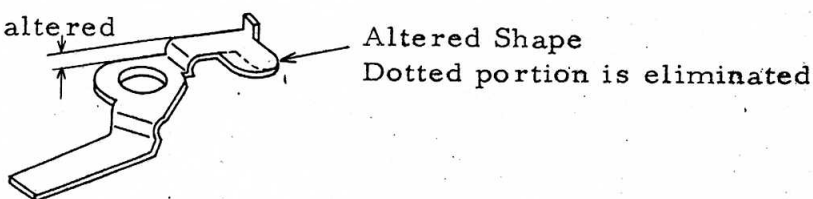
Rewind clamp Lever 13-8194

0.4 is altered
to 0.6
