# Canon SERVICE MANUAL REPORT

Serial No. AC10-016

## REGARDING CHANGED IN CHECKING METHODS FOR SHUTTER RELEASES OF CANON FX AND PELLIX

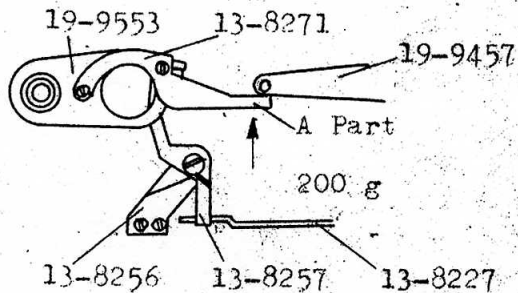
(New Checking Method)

Recently there have been many claims that the shutter does not release even though the shutter button is pressed. The reason for this is that the mirror clamp lever (13-8257) does not get released. Heretofore, the release of the mirror clamp lever was judged good when the difference between how strong the mirror charge lever (19-9553) was set and the weight of the release of the mirror clamp lever was 40 g. However, due to fluctuations in measuring and instability in the checking method, we have changed the checking method as follows:

The mirror clamp lever (13-8257) should come loose when the shutter button is pressed while pressing the A part of mirror charge lever (13-8271) at 200 g with a tension gauge.
