Canon SERVICE MANUAL REPORT

Serial No. AL 5-007 E

Service Manual No. L-005

Canon FD WIDE ANGLE Lenses Changes

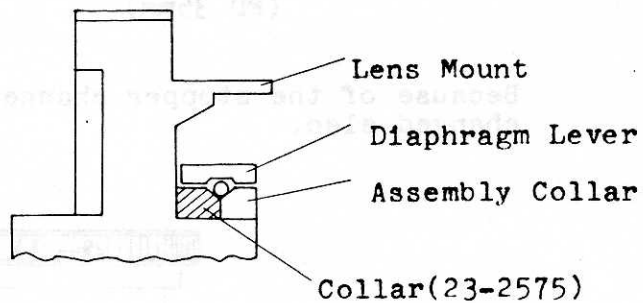
To improve quality, the cross-hatched part has been removed from the lens mount and made a separate part [Collar(23-2575)].

Camera Service will stock only the new lens mount and the collar. If an old mount is replaced with a new one, be sure to add the collar also.

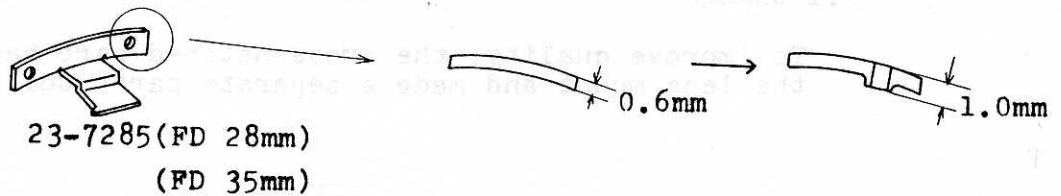
Bayonet Stopper(23-7285) had a tendency to crack around the screw holes, so the ends of the stopper around the screw holes have been thickened as shown in the drawing.

Old and new parts are interchangeable, but if the new stopper is used, the new aperture ring must be used also. Camera Service will stock only new parts.

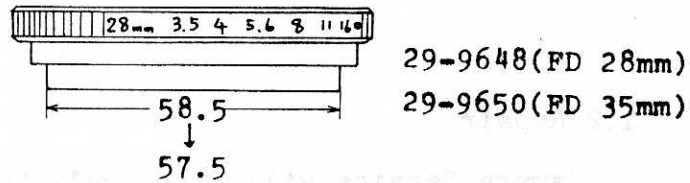
Because of the stopper change, the aperture scale ring has been changed also.
