Canon SERVICE MANUAL REPORT

Serial No. AC10-016

Issued by Service Department, Canon Camera Co., Inc.

REGARDING CHANGED IN CHECKING METHODS FOR SHUTTER RELEASES OF CANON FX AND PELLIX

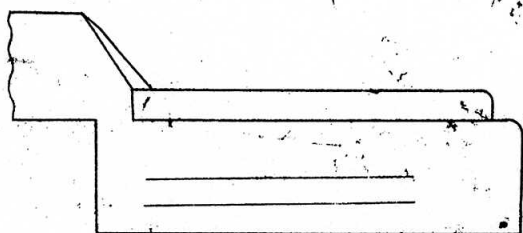
CANON CAMERA COMPANY, INC.
NO. 100001 MADE IN JAPAN
19-9517

With the alteration of the name, the top cover and the base plate are modified. The carving CANON CAMERA COMPANY, INC. NO. 100001 MADE IN JAPAN on the backside at right hand side of the cover is abolished, but 100001 is put on the surface at left hand side instead and CANON JAPAN is also put on the surface of the base plate.
